भारतीय रेल (रेल मंत्रालय)
डीजल रेल इंजन कारखाना
INDIAN RAILWAYS (MINISTRY OF RAILWAYS)
DIESEL LOCOMOTIVE WORKS
VAPANARI-221004, MD A

No. dlw.m.65.262 &
DLW/TOT/1666

DESIGN BULLETIN

1. **Design** DB/03/2013/06
2. **bulletin no.**
2. **Subject** Modification in electrical circuit to avoid discharge of battery in HHP locos due to repeated cranking.
3. **Background** In the existing electrical circuit, if fuel pump motor fails and cranking is attempted, starting motors starts drawing current and discharge the battery. In addition when EFCOR is in denergised/ drop out condition (open circuit of coil, defective NC interlock of SDR (Shut Down Relay) and open circuiting of wire from SZ6 wire to EFCOR coil), the starting motor shall draw current if cranking is attempted.

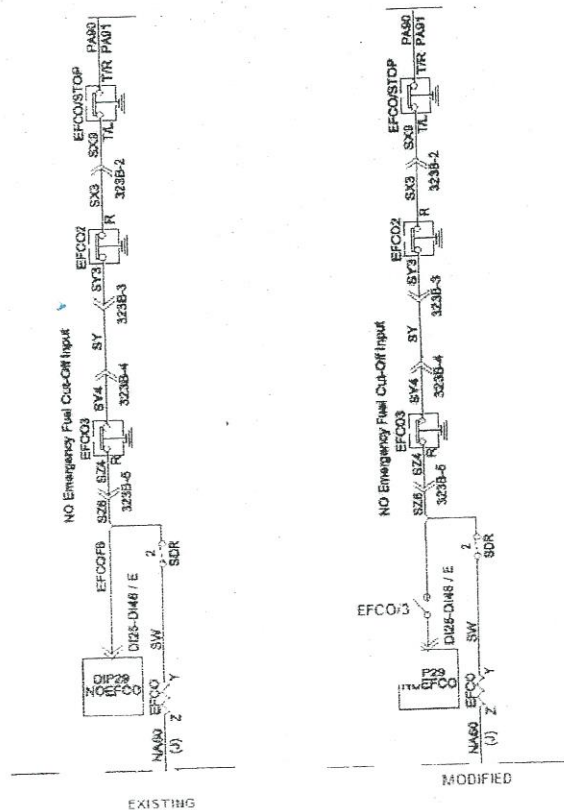
EFCO circuit modification for avoiding draining of battery

During analysis, it is noted that even if EFCOR is open circuited, digital input signal (NO EFCO FEEDBACK) shall be available to LCC; which permits the engine to crank, but firing shall not take place because DV solenoid shall be in energised condition. This causes draining of battery due to repeated cranking.

NO interlocks of EFCOR is to be connected in series with EFCO push button switch NC interlocks EFCO1, EFCO2 and EFCO3 feeding supply Digital input signal (NO EFCO) to MLCC.

By implementing this circuit modification, cranking can be prevented during the occasions such as EFCOR coil open circuit, SDR NC interlock defect.
